Ndola – Dingaon Xfr 33kv

## Ndola Dingaan 33kv Transformer Combi installation 22 July 2017

## Ndola 33kv Dingaon transformer 1010

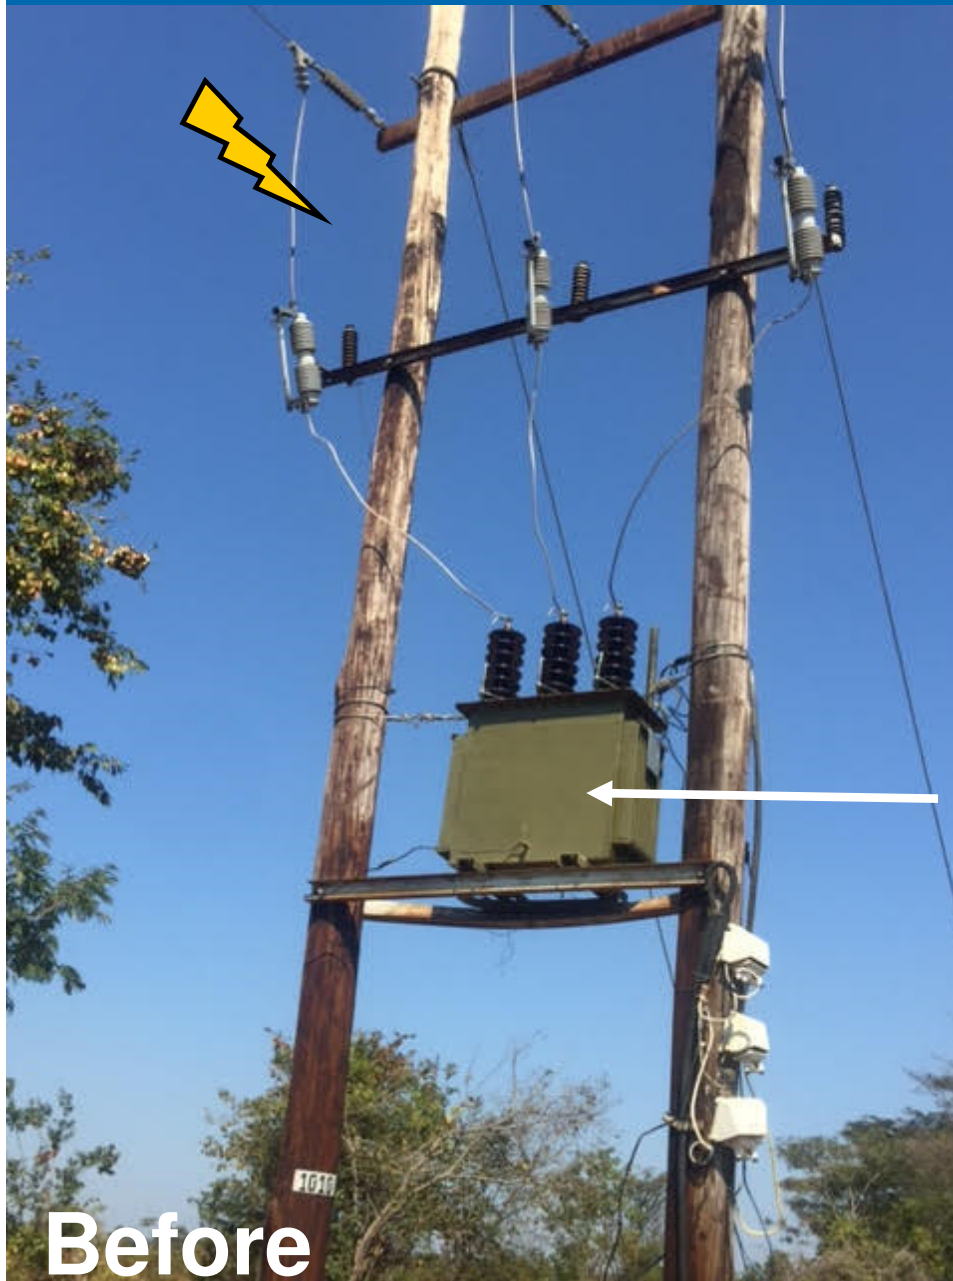
4x Transformer has been lost.

High lightning intense region.

All surge arresters are blown.

Surges take too long to replace. Surge arresters blow without staff knowing.

Transformers blow b-annually and do not reach their 20 year. 4x Transformers have been lost at this site in 2016- 2017 ( in a 12 month period.)

Bonding us incorrect.

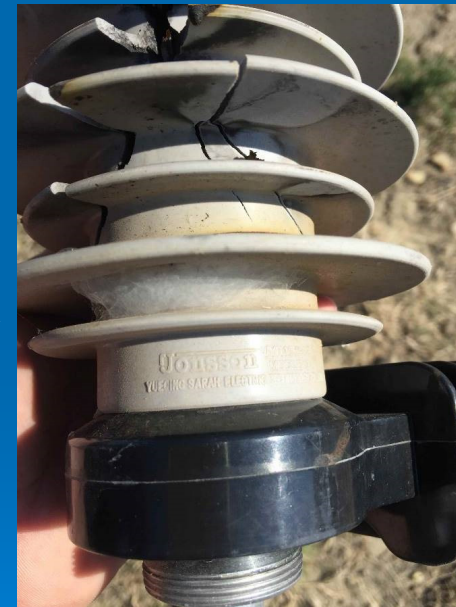
Surge arresters expire and don't get replaced in time before the next Lightning strike.

Conventional surge arresters don't alert you when they are expired & are never replaced.
