Specification for a combined cut-out fuse and drop-out surge arrester unit.

## APPLICATION OF THE COMBI UNIT – FREE STATE OPERATING UNIT

### **Free State Operating Unit**

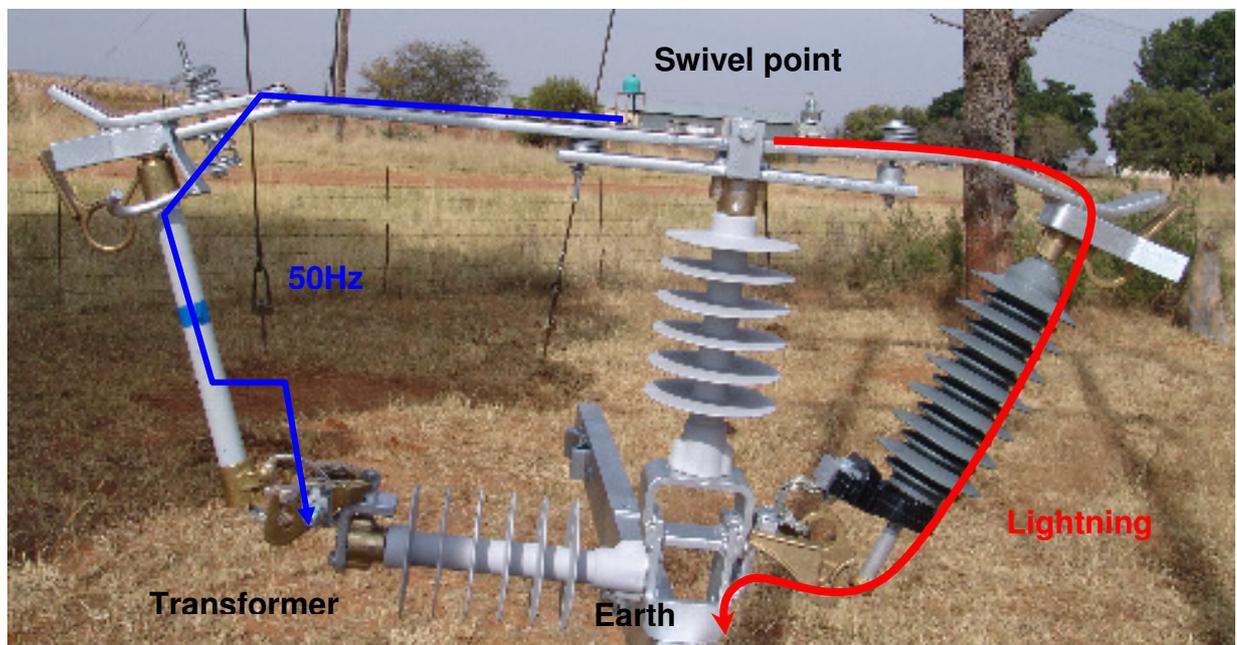
The Combi unit consists of a post insulator in the middle with a drop out type surge arrester on the one side and a drop out fuse on the other side. Should the fuse blow, only the fuse will fall open while the arrester stays closed. In the case where the surge arrester GLD operates, both the fuse and the surge arrester fall open. Figure 1 shows a Combi unit

Figure 1, A Combi unit set up for tests.

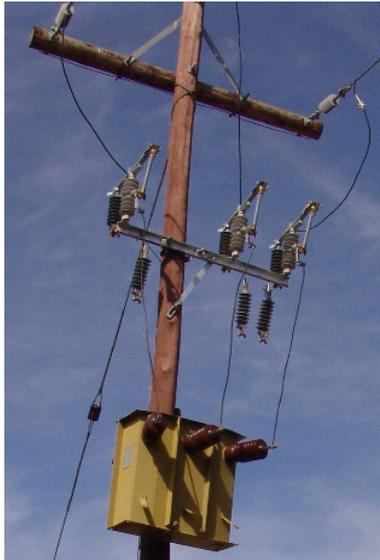
Single pole arrangement

Figure 2 shows a Combi installation. Spare arresters are left on site (hanging on the cross arm) to ensure that a failed arrester does not cause any further interruption of supply.

*Figure 2. Combi installation*

On installation of the Combi, the surge arresters (on the transformer tank) at a pole mount installation are removed and the fuse assembly is replaced by a Combi unit. A proper earth bonds the transformer tank with the Combi installation.

The Combi surge arresters will protect both the fuse and the transformer. As the arrester should physically not be too far from the transformer (less than 2 metres), the Combi need to be placed between 1.2m and 2m above the transformer. A Combi unit can therefore not be placed at the T-Off, one structure away from the transformer

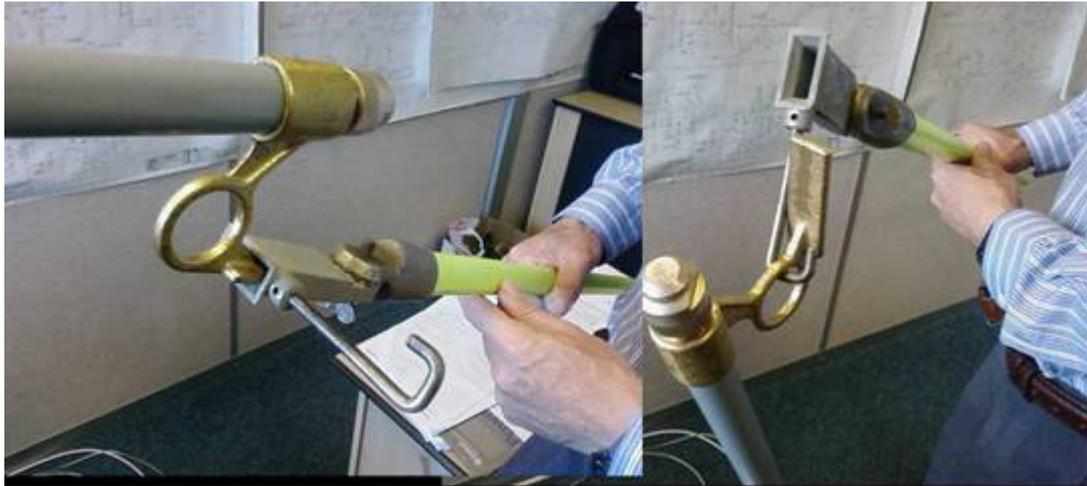
In order to curb these incidents, a new device (insertion tool) was developed to be used for installing fuses and drop out arresters. It is easier (more stable) to install the fuses and arresters. Secondly, it is unlikely that the fuse / arrester will slip / unhook from the link stick. Figure 3 shows the insertion tool.

*Figure 3. The insertion tool to replace fuses / drop out surge arresters*
