Combi installation 15 November 2017

Addis Ababa – 100kv Xfr 36kv

Addis Ababa 36kv Transformer Combi installation

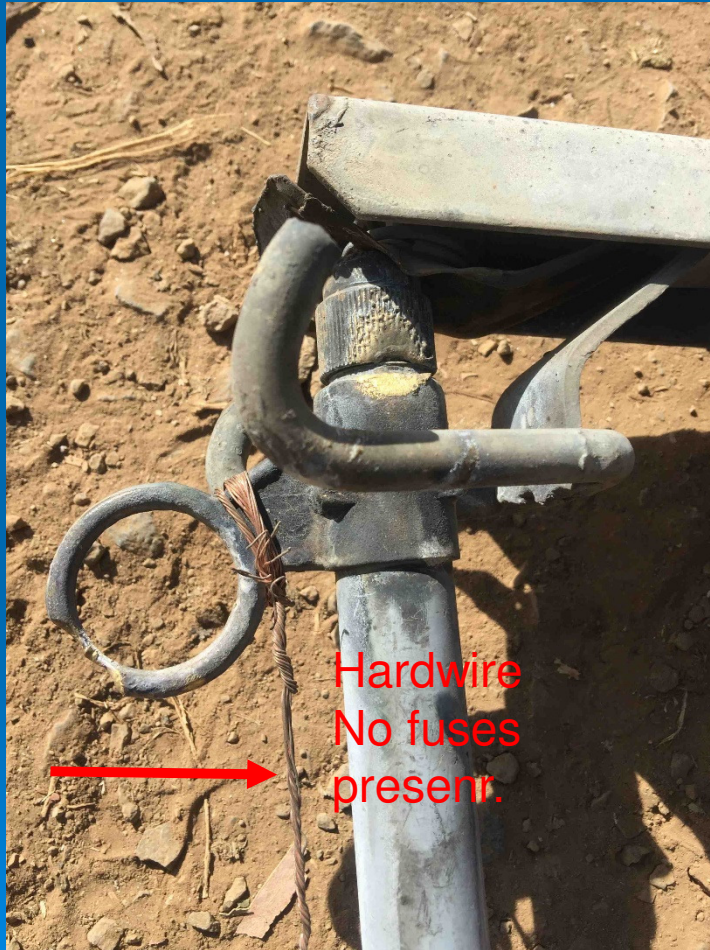
4x Transformers were lost in 2016/2017 and all the fuses and surge arresters were blown

All fuses were blown

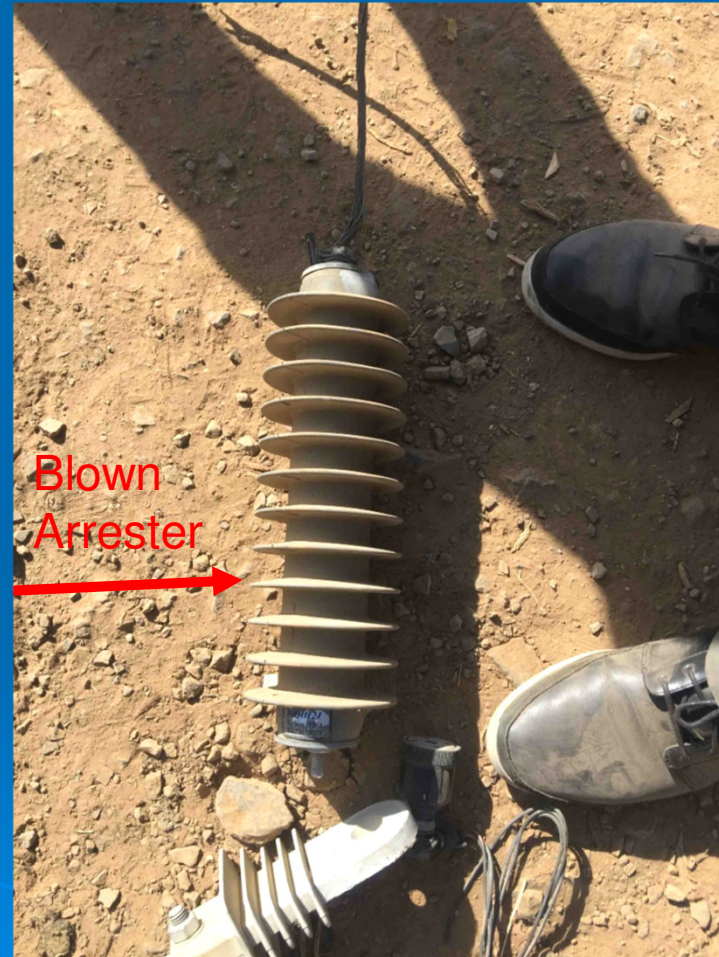
All surge arresters were blown

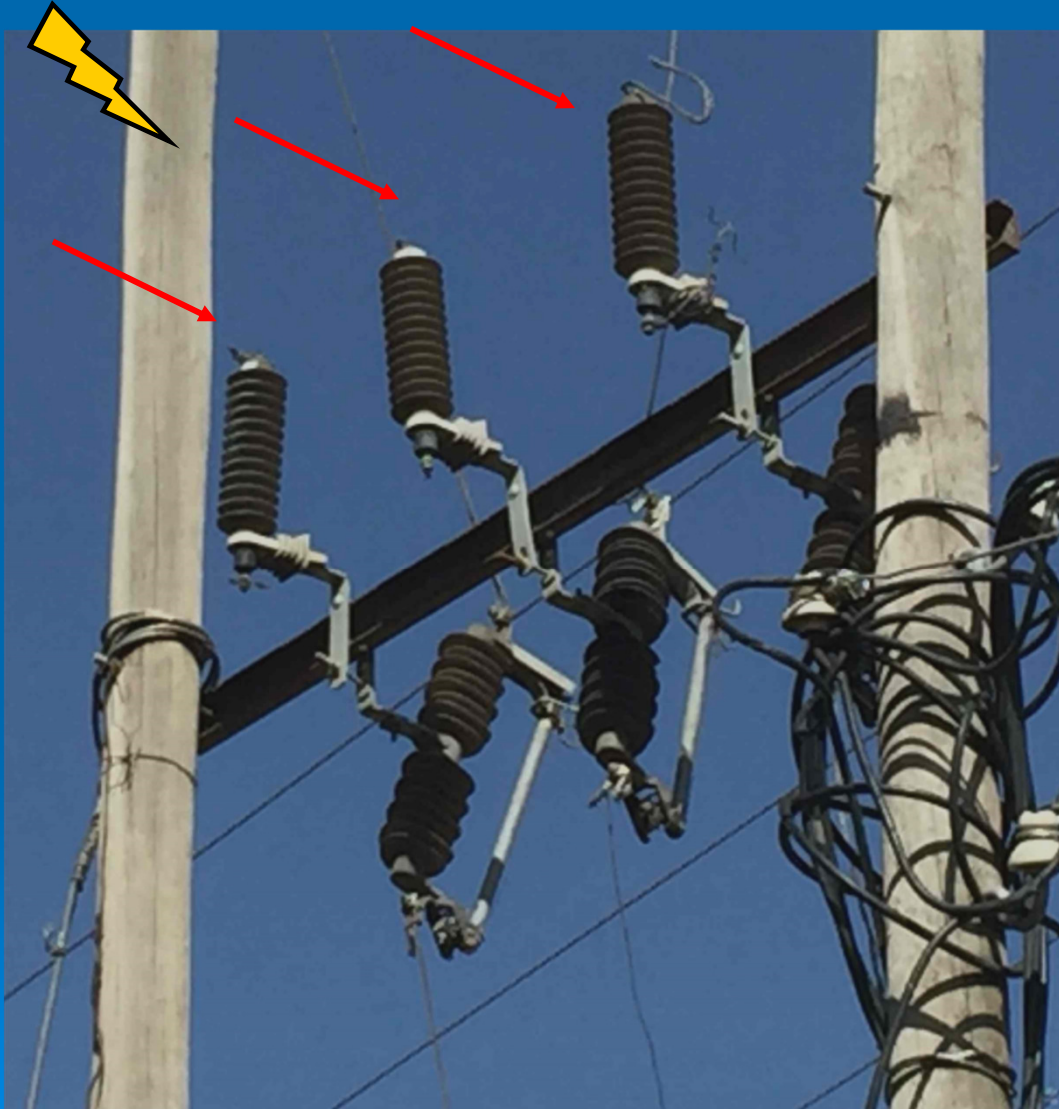
Before

All Surge arresters are cut away , meaning zero protection

Problems with the site

4x Transformer has been lost in 2017 due to lightning.

High lightning intense region.

Surges take too long to replace.

Surge arresters blow without staff knowing.

Technicians cut away old surge spent surge arresters.

Bonding is incorrect.

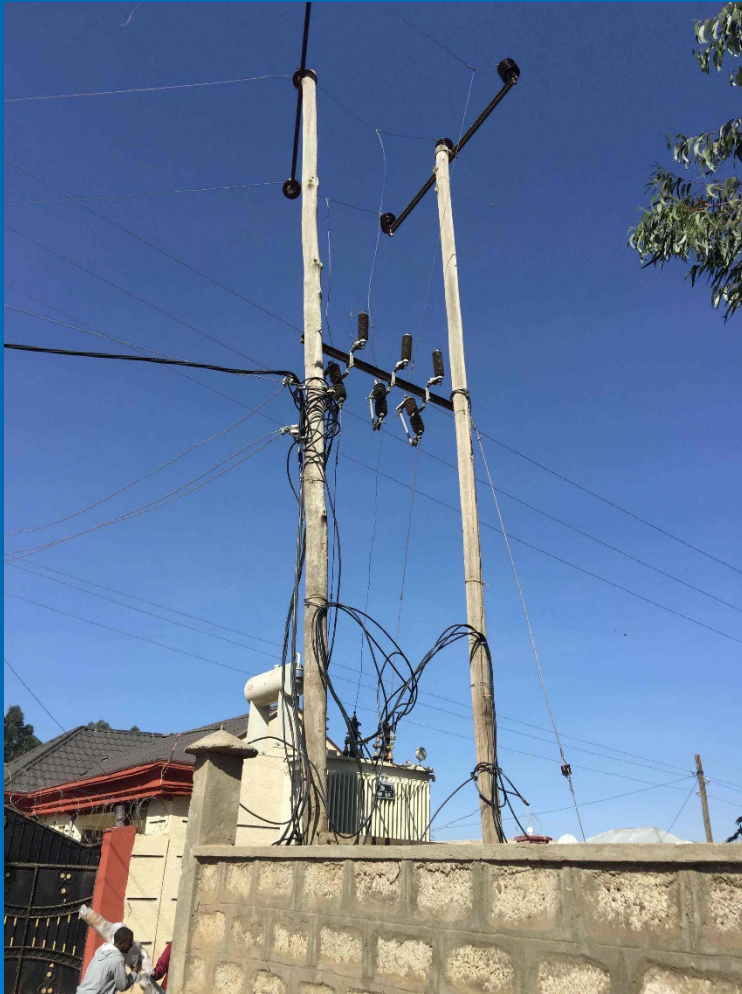
Before

No bonding

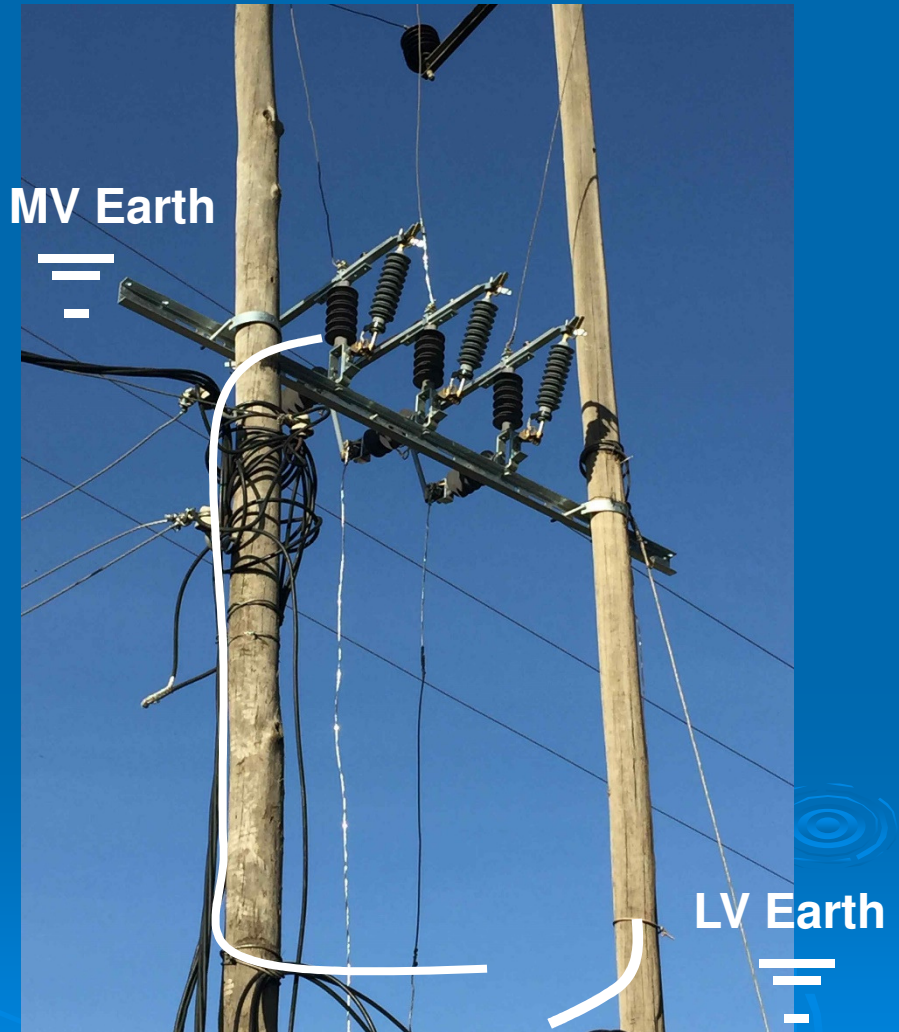
After

2x (MV & LV) Earth bonded system

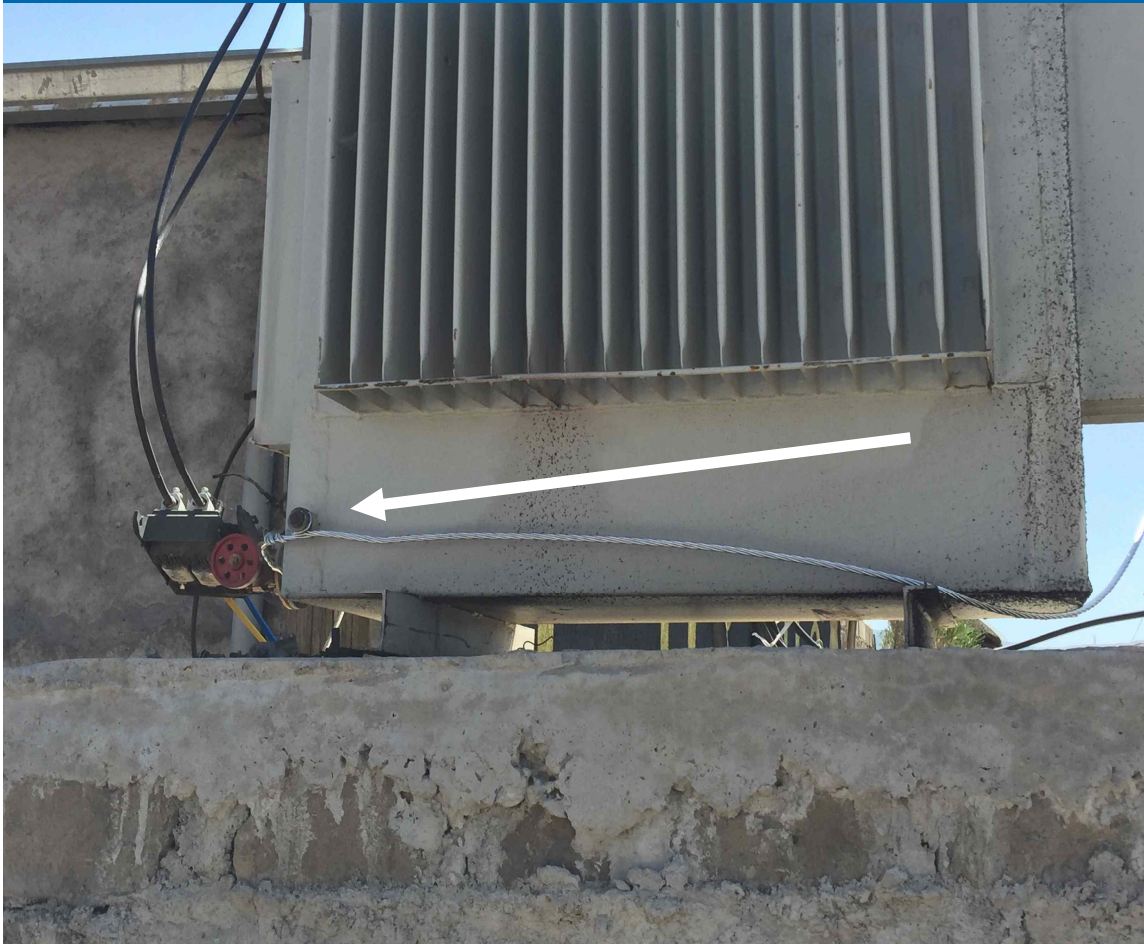
After

Combi – 2x Earth bonded system

MV Bonding

Copper cable 35mm must be connected between the Combi pole clamp and the transformer body.

Bonding is vital for the transformer Protection. This is connected into the crowfoot.

The voltage inside and outside of the transformer must be at the same potential during a lightning strike.

LV Bonding

Copper cable 35mm must be connected from the neutral bushing and the transformer tank.

This is connected into the crowfoot.

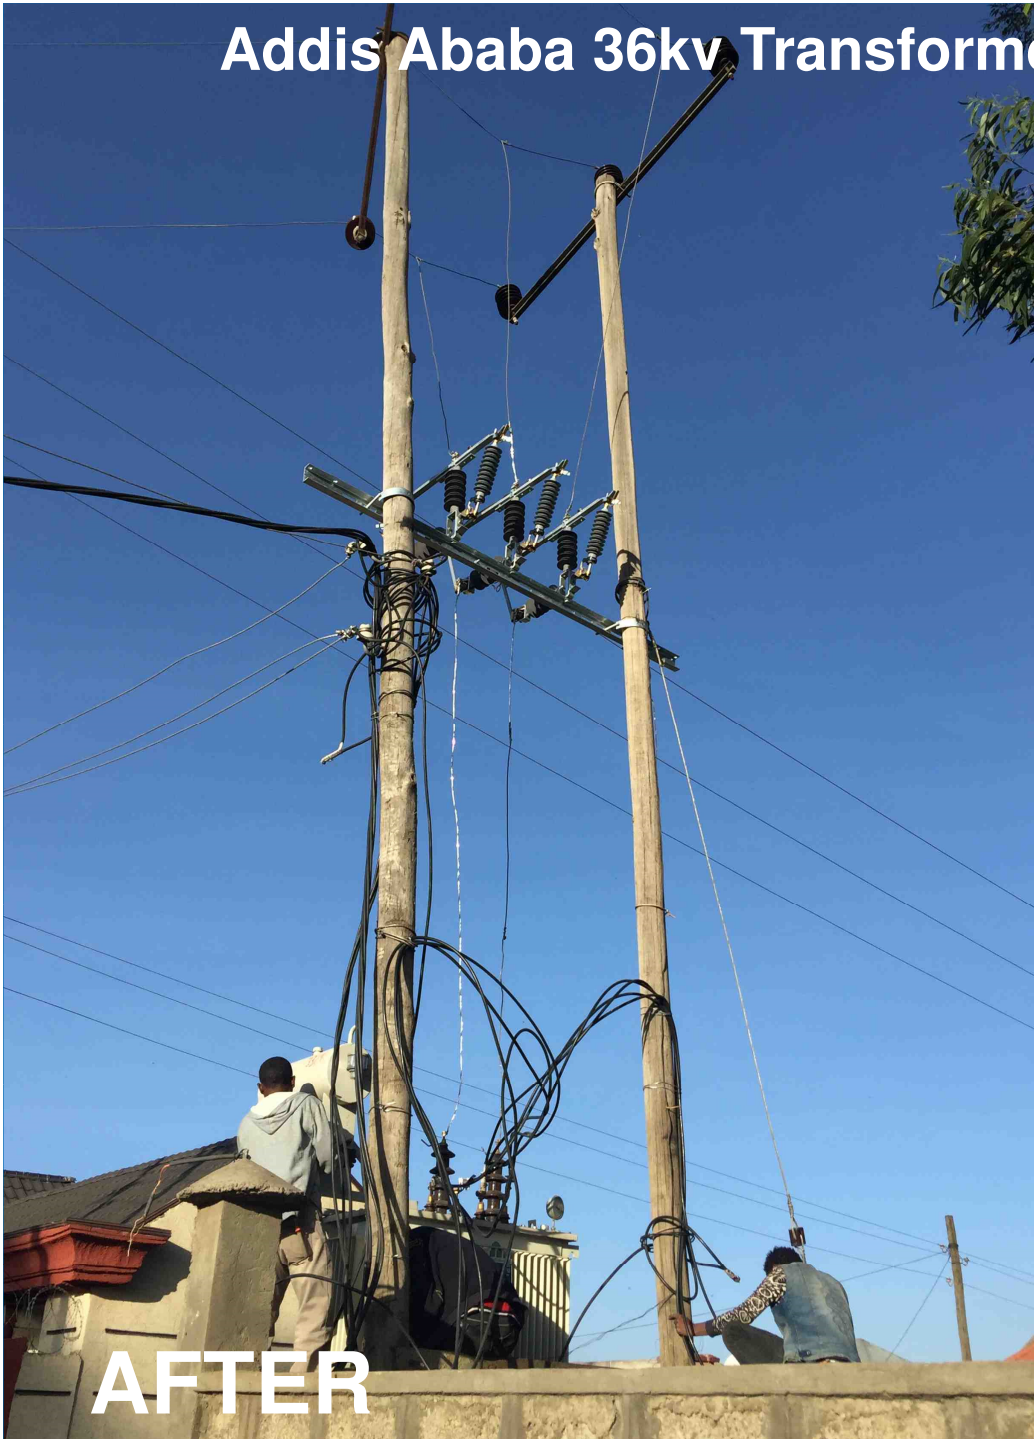
AFTER

Improvements :

Surge arrester has 100% chance of replacement.

Replace surge arrester with link stick & safely from ground.

Transformer surge protection is improved significantly. Transformer survives for 20 years.

Surge arrester alerts you when it is spent

Surge arrester replacement

- Is a 30 seconds operation
- rather than 3 hours.

Safer, Quick & Fast, Easier to replace.
