Tanesco , Mambo view, 33kv 50kva Transformer installation, 14.06.2017

Distribution Transformer protection

Transformer Combi Unit protection

Presented by : - Live Line Technology June 2017

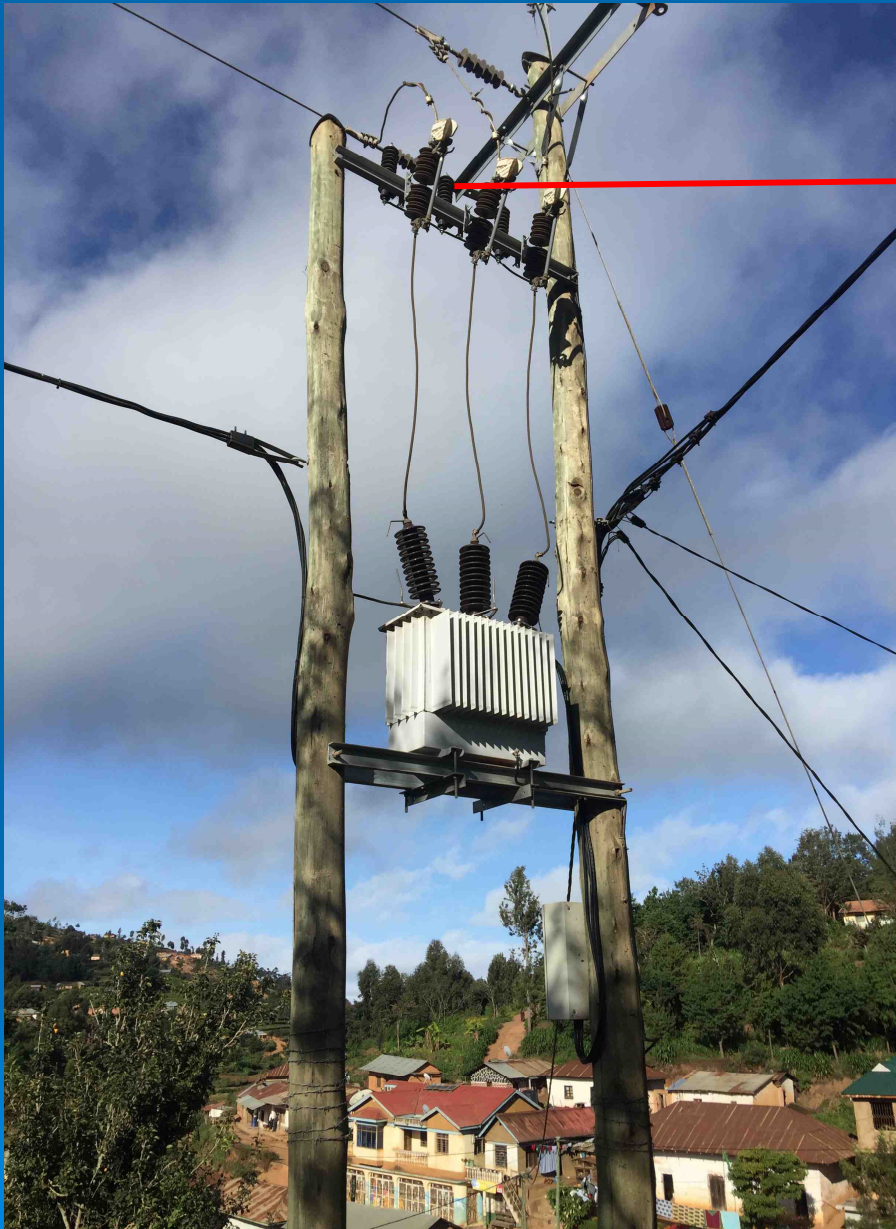
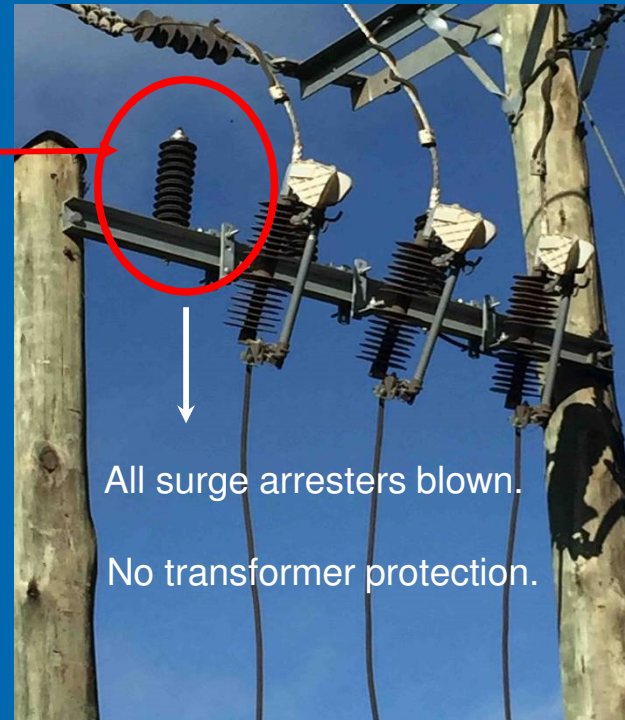
BEFORE

All surge arresters blown.

No transformer protection.

Problems with the installation –

- Zero surge protection, at the transformer. (All three surge arresters were blown.)
- Maintenance takes too much time. (not done)
- The Faulty spent surge arresters were very difficult to identify and remove – it took 24 hours to identify. Customer without power for long.

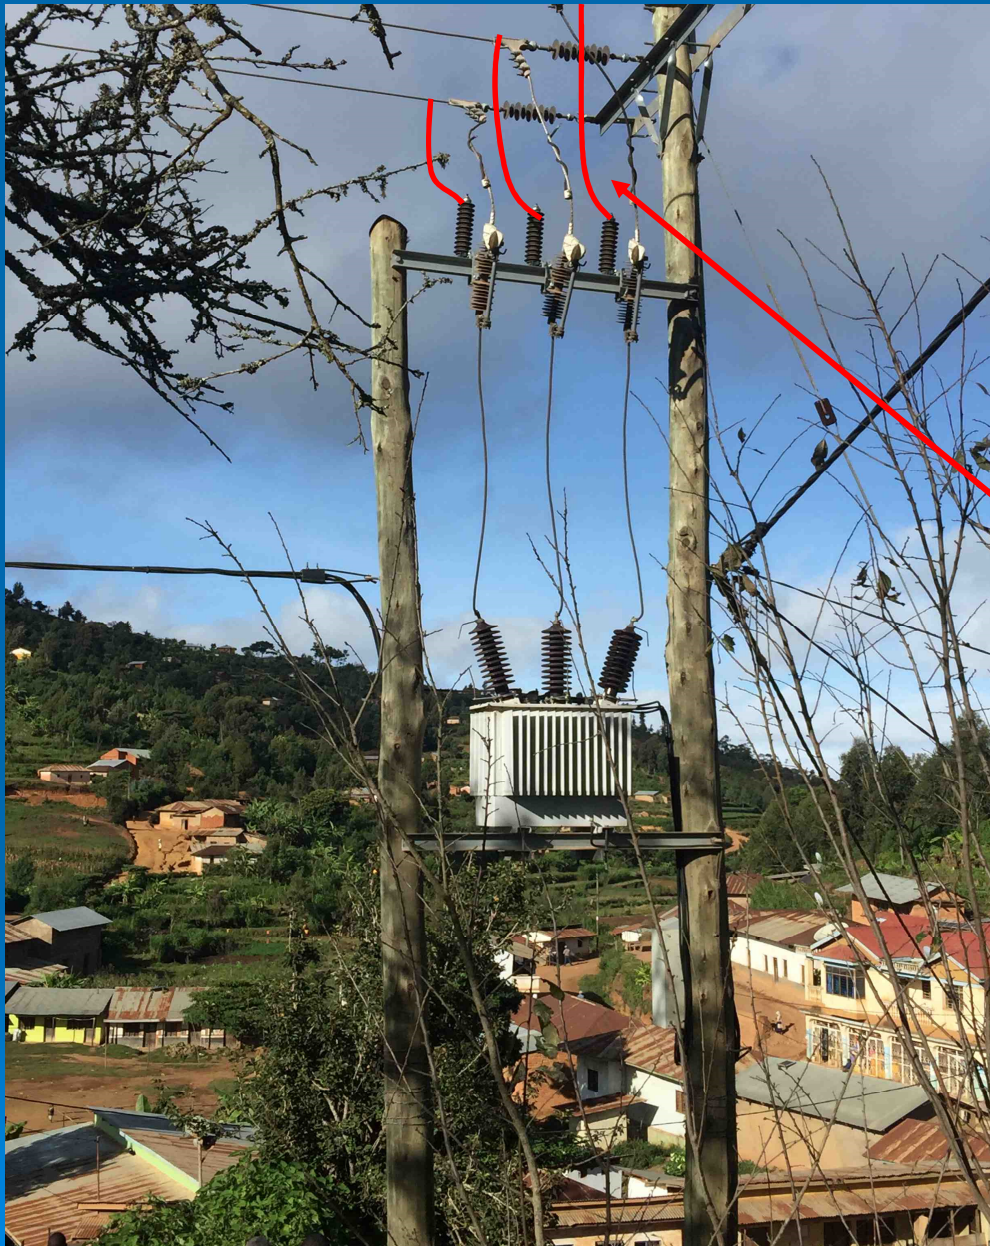
BEFORE

Problems with the installation –

Surge arresters have been spent/discharged and have disconnected which means transformers are vulnerable to lightning damage.

The Combi unit can be installed in high lightning dense areas to overcome this problem.

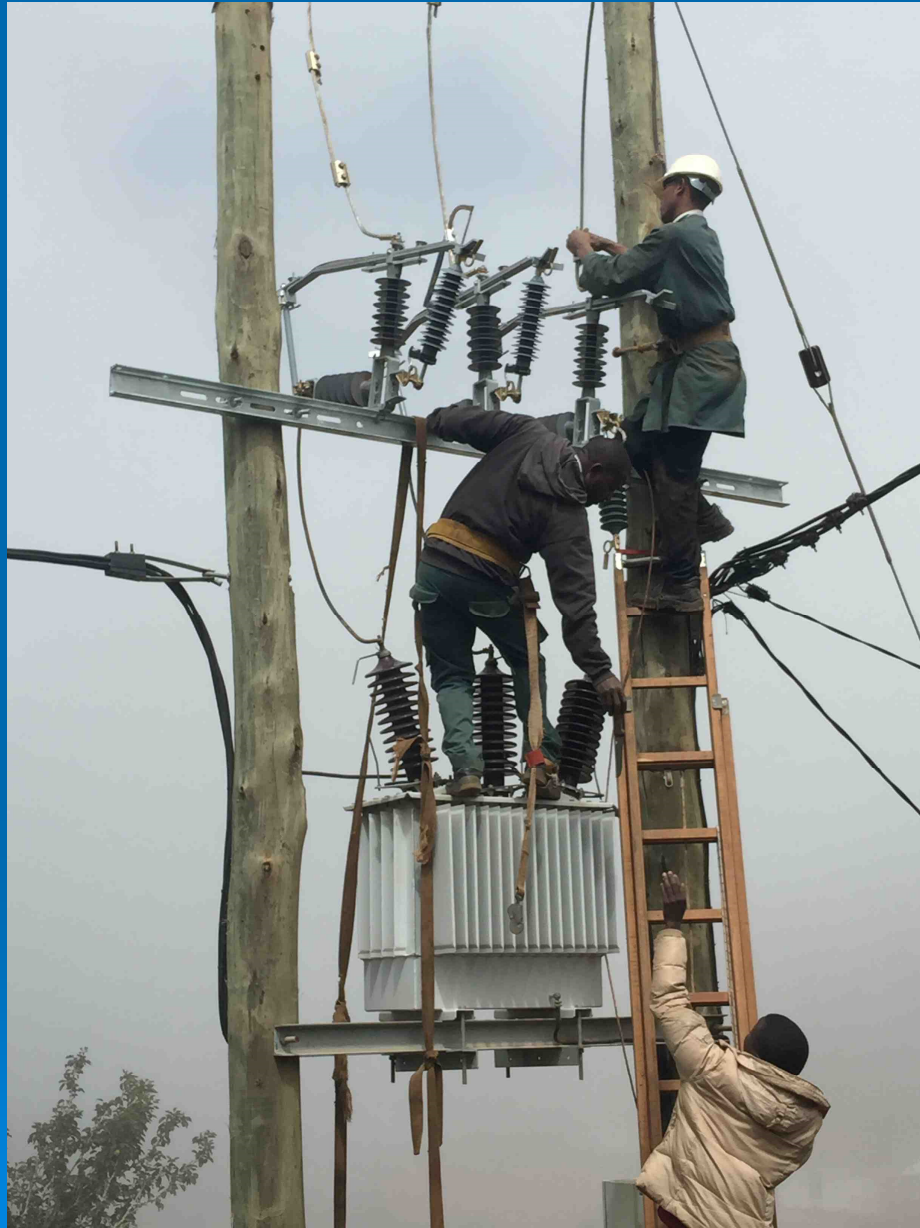
INSTALLATION

Installation :

- Retrofit is fast
- Remove the old system.
- Remove : old cross-arm, fuses and old surge arresters
- Installation is completed in 2-3 hours.
- The Combi unit takes the place of both the fuse and surge arrester.

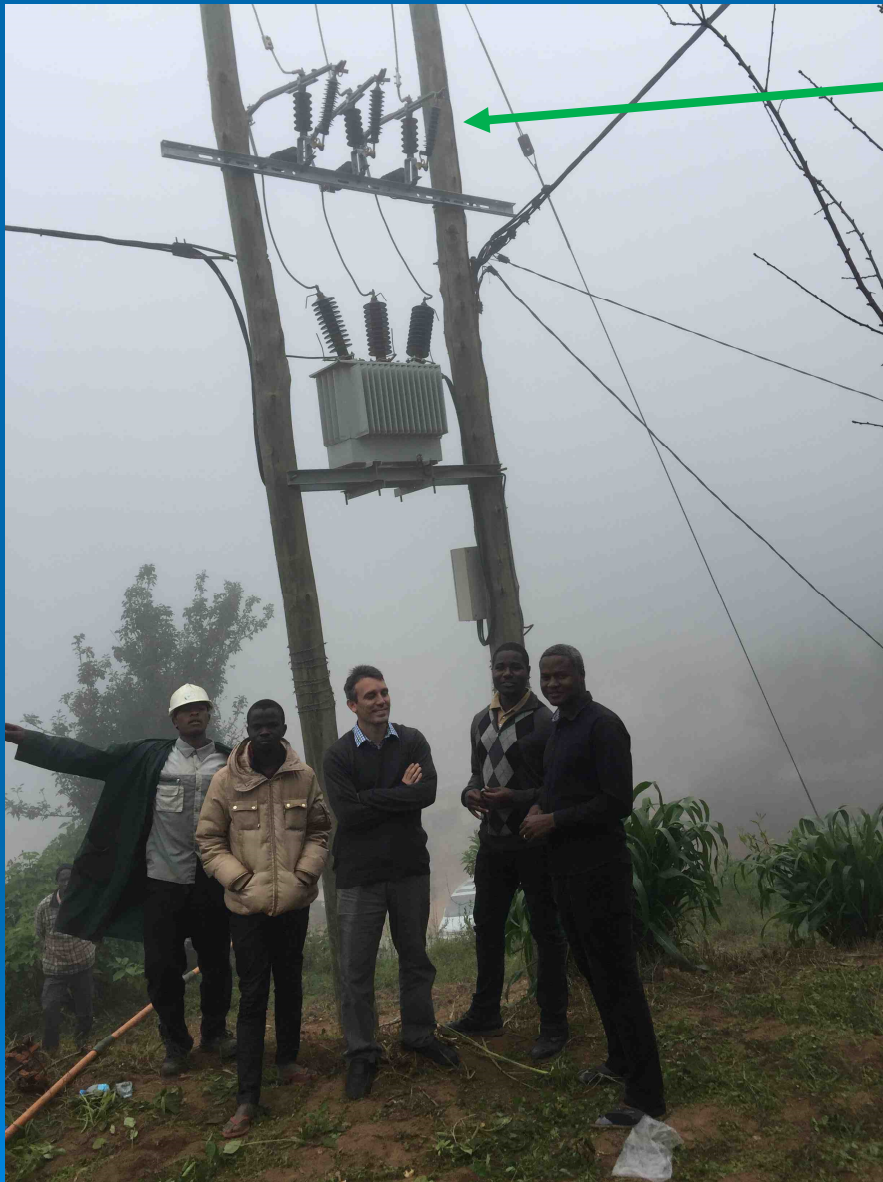
AFTER

Combi unit protection system :

Link stick replacement system.
(fuse & surge)

Replace surge arrester live line.

Replace surge arrester from ground

This latest technology does not rely
on a ladder for maintenance.

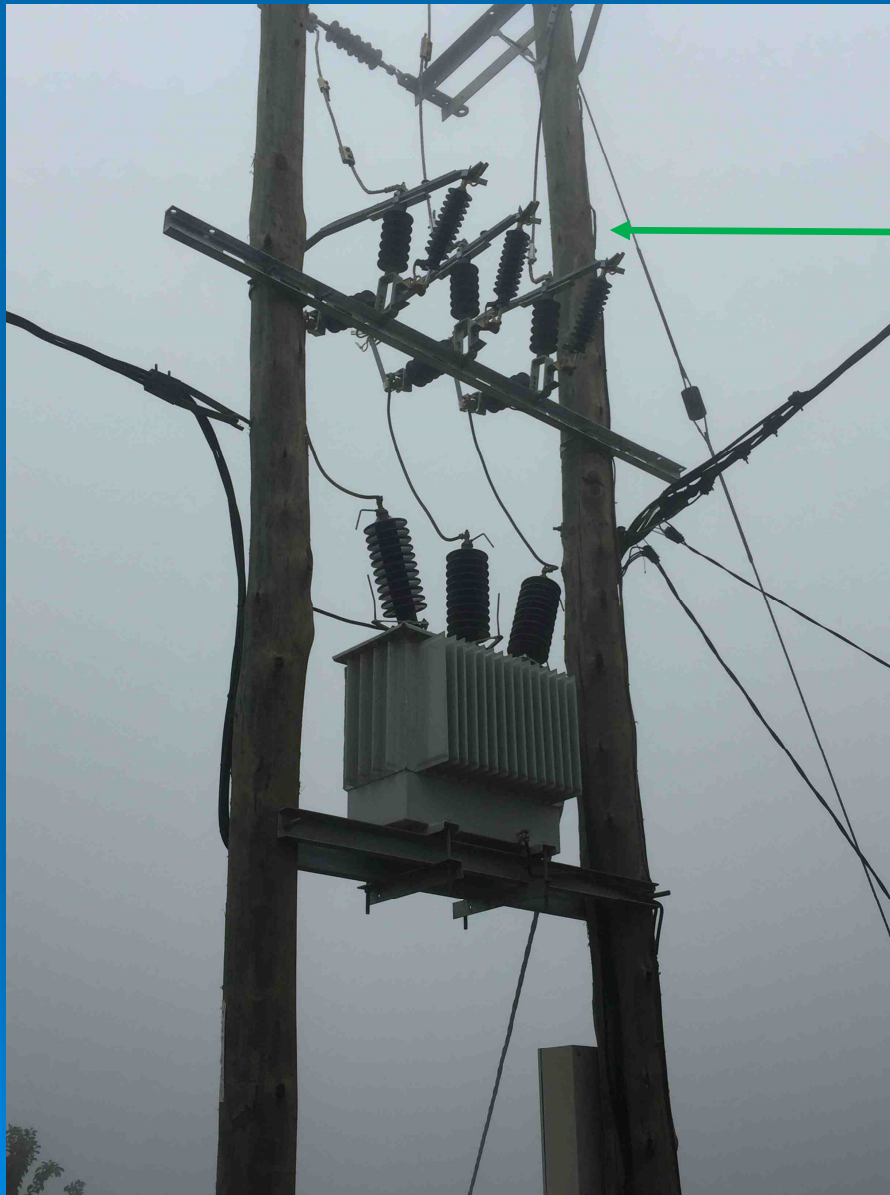
AFTER

ADVANTAGES –

1. The Combi unit saves transformers. they survive 20 -30 years.
2. The Combi unit improves maintenance and protection.
3. The Combi unit is the safest system for personnel. They don't need to climb poles. (they use link sticks for operation)
4. The Combi unit is safest option for transformer.
5. The transformer cannot provide power until a new surge protection device is installed.

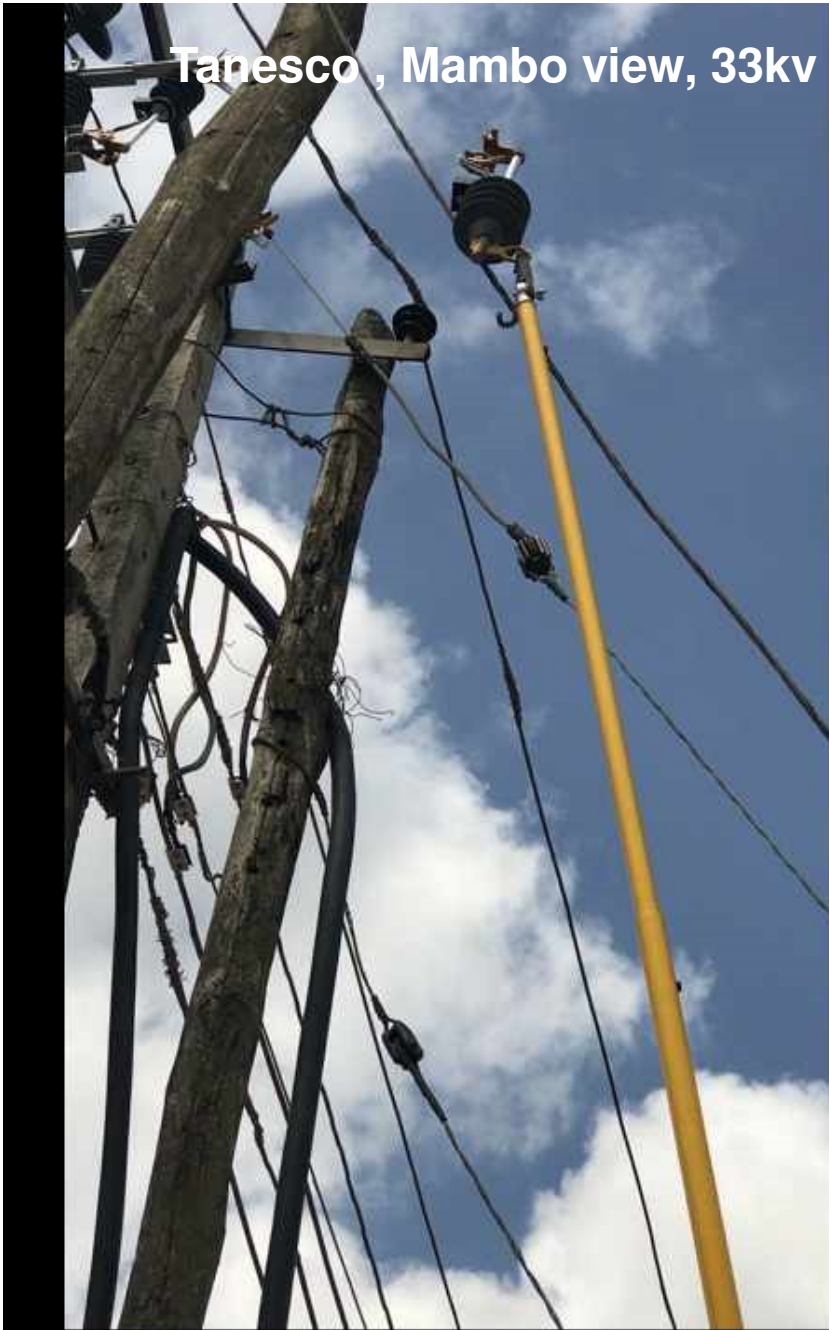
AFTER

Combi unit protection system :

1. Surge arrester changed by link stick
(NO OUTAGE required from Substation)
2. Fuse protected by surge arrester. Eliminate fuse blows, eliminate random outages Latest technology, much lower running cost.
3. Fuses changed by link stick
(NO OUTAGE required from Substation)
4. Best customer service. Maintenance only affects customer connected to transformer.
5. Tanesco electricity increases revenue –
Shorter outage duration during maintenance
