# Lightning protection for equipment on MV feeders

By WJD van Schalkwyk and M du Preez, Eskom

*This article presents the influence of lightning on MV feeders supplying small power users (400/230 V) with focus on insulation failures leading to poor power quality. In order to minimise power interruptions, lightning-related trips are reduced mainly by minimising MV equipment failure. Examples of arc quenching are included.*

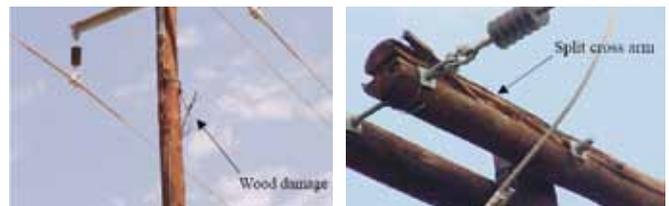
Figure 2: Wood damage due to lightning

A feeder's lightning performance is measured against the number of trips due to lightning. This research was done by monitoring the Theunissen – Brandfort pumps (TBP) 11 kV feeder's performance. (This is located in the middle of the Free State province, South Africa). The 300 kV BIL design resulted in substantial damage due to wood splitting. Investigation [2] undertaken shows that impulses due to lightning strikes with magnitudes of higher than 7 kA can cause splitting of the wood (see Figure 2).

Replacing damaged wood poles results in customer outages. Sometimes the damaged pole is also in very difficult or inaccessible terrain. It is therefore necessary to prevent wood splitting as far as possible. The detailed study was based on actual measurement of lightning (direct and indirect flashes) to investigate whether the BIL cannot be lowered by doing away with the bare wood gap.

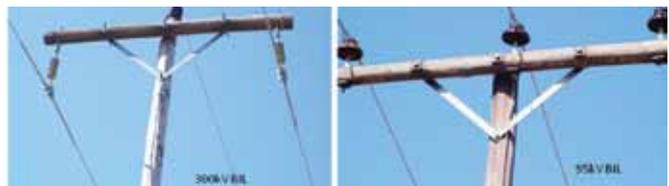
Figure 3: 300 kV BIL and 95kV BIL structures.

In the TPB feeder, the BIL varies from 95 kV to fully insulated wood poles (no bonding or any earth wires). About 10% of the poles are fitted with 150 kV BIL insulators in series with a 150 kV BIL wood insulation to earth (totalling 300 kV BIL). The rest of the poles are fitted with 95 kV BIL porcelain insulators. About 30% of these wood poles are fully insulated (no bonding earth wire) – the rest (60%) are either fully bonded (BIL around 95 kV) or have a very small wood gap. Figure 3 shows the typical feeder poles.

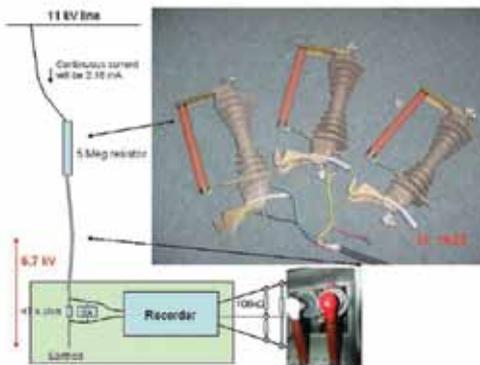
Figure 4: Measurement equipment setup (A).

to monitor current and voltage on the feeder. The loggers are synchronised with GPS timing resulting in the lightning surges on the power frequency being accurately time stamped. The recorder has two three phase inputs – one for the resistor voltage divider and one for the breaker CTs. A resistor voltage divider was installed to capture voltage recordings and the current is recorded by using the relevant protection CT (600/1 CT ratio) of the feeder breaker. The basic setup of equipment is shown in *Figures 4 and 5*.

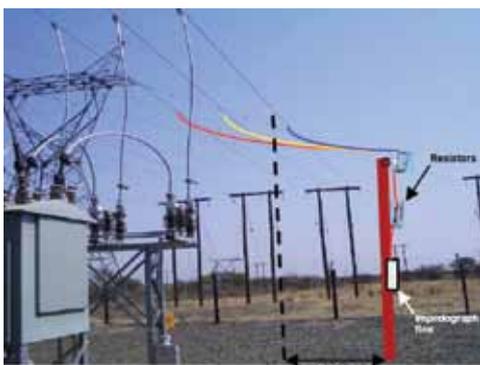
Figure 5: Measurement equipment setup (B).

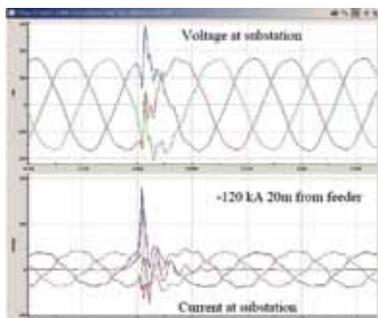
Figure 7: Voltage and current waveforms measured at the substation.

The worst case indirect lightning stroke was found to be a -120 kA stroke 20 m from on section of the feeder that did not cause a flashover. At that point the feeder's BIL was 190 kV (150 kV line insulator plus 40 kV stay insulator). Figure 7 - Figure 10 show the measured waveform, the LTS result and a photo of the site.

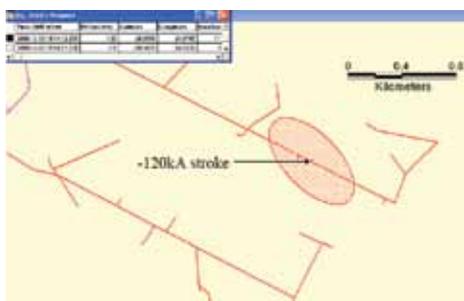
Figure 8: Lightning tracking system result.

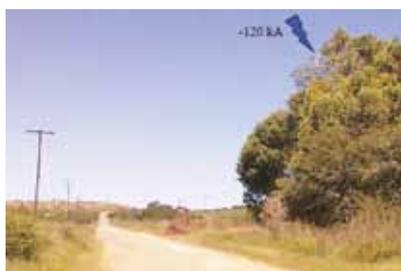
Figure 9: The scene.

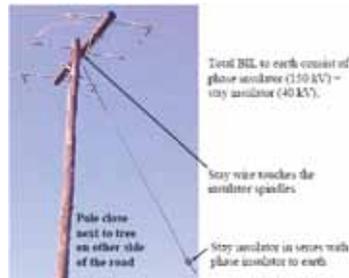
Figure 10: Pole closest to the tree where a -120 kA stroke terminated.

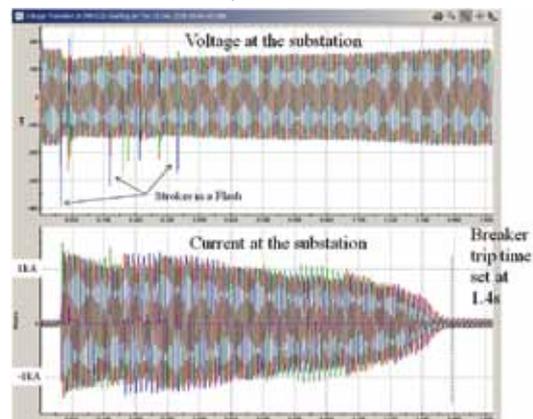
Figure 11: Example of a three phase fault that quench after 1 360 ms, just before the over-current protection operated.

Arc quenching is caused by one of the following: Wind that blows the arc away; hot air around the arc rises, causing the fault path resistance to increase until the arc self-extinguishes or a magnetic force that blows the arc away.

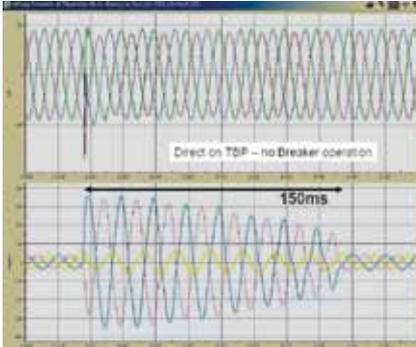
Figure 12: Phase to phase fault that quenched.

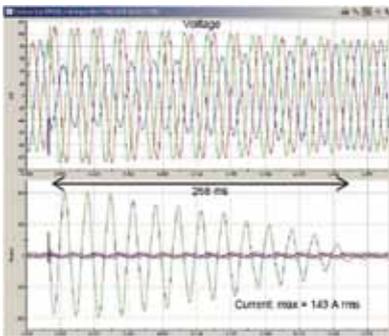
Figure 13: Single phase fault that quenched.

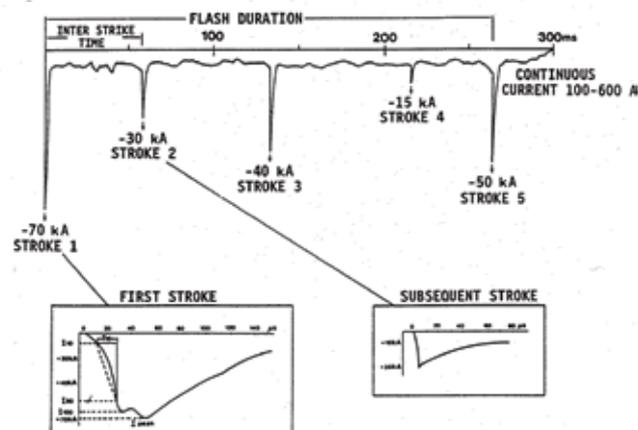
Figure 17: Three basic components found in a lightning flash [4]

It is relatively easy to grade fuses for correct 50 Hz current operation, but fuses are also sensitive for high currents such as these found in lightning. Normally lightning consists of a first stroke followed by several subsequent strokes as it can be seen in the illustration shown in Figure 17.

The illustration shows that lightning consists of three major components namely an amplitude component, the rate at which the current rises and an energy component that exists due to the dc current found within a lightning flash.

The total surface area underneath the wave form represents the energy that needs to be dissipated by the fuse and surge arresters on the line.

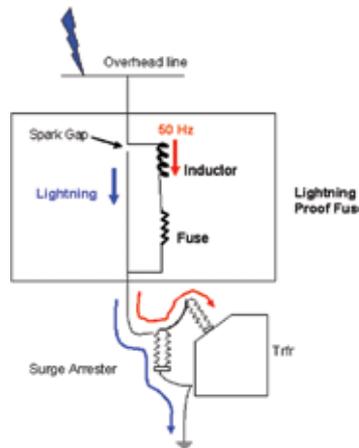
Figure 18: Circuit configuration including a lightning-proof fuse.

By introducing a spark gap in parallel with a fuse, which is in series with an inductor into the circuit, with the latter acting as a low impedance path at 50 Hz and as a high impedance device at lightning frequencies it was found that the arising problems due to lightning frequencies can be avoided with great success.

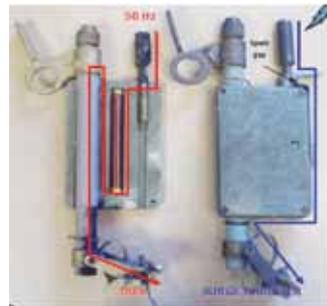
Figure 19: Lightning-proof fuse operation.

This will ensure that the fuse will work correctly for normal over current situations. However, from Equation 1 it can be deduced that the impedance of the circuit will be high for lightning frequencies resulting in the current attempting to find an alternative conducting path. The maximum volt drop across the inductor is 75 kV at lightning frequencies and 0,15 V at 50 Hz. The power frequency will pass through the inductor and fuse while the lightning impulses will flash over the spark gap, bypassing the fuse element.

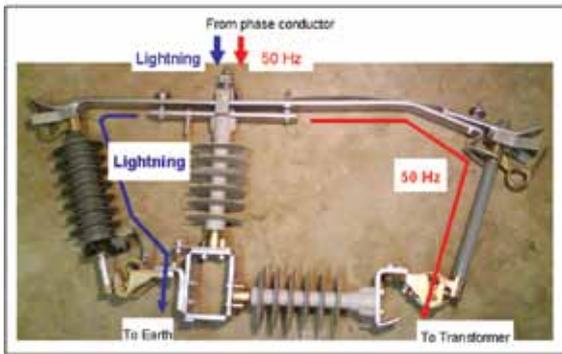
Figure 20: Illustration of the operation of the Combi unit.

The Combi unit consists of a post insulator in the middle with a drop out type surge arrester on the one side and a drop out fuse on the other side. Should the fuse blow, only the fuse will fall open while the arrester stays closed. In the case where the surge arrester GLD (ground lead disconnect) operates, both the fuse (fuse element still healthy) and the surge arrester fall open.

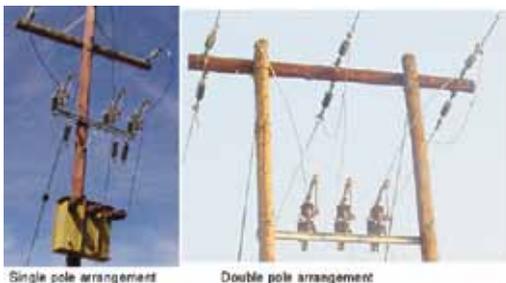
Figure 21: Combi unit installations.

The Combi Unit was initially developed to minimise the MV fuse and transformer failures during lightning activities. The MV fuses were exposed to lightning due to the pole mount transformer configuration as it was installed line side of the surge arrester. The surge arrester was only protecting the MV transformer. Should the arrester be placed line side of the fuse to protect both the fuse and transformer, the arrester could only be changed after the feeder was isolated.

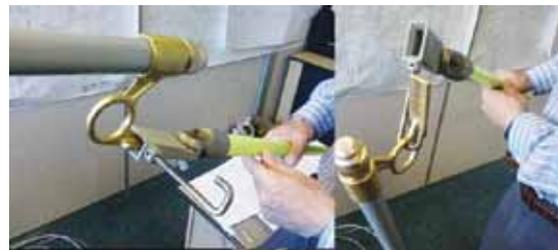
Figure 22: The insertion tool to replace fuses and drop out surge arresters.

To minimise the risk of falling objects, a tool was developed to replace drop-out surge arresters and fuses from ground level using a link stick. Figure 22 shows the insertion tool.
